**REPORT ON CONDITION  
STELLING MINNIS VILLAGE HALL  
KENT CT4 6AG**

**DANIEL MARTIN**

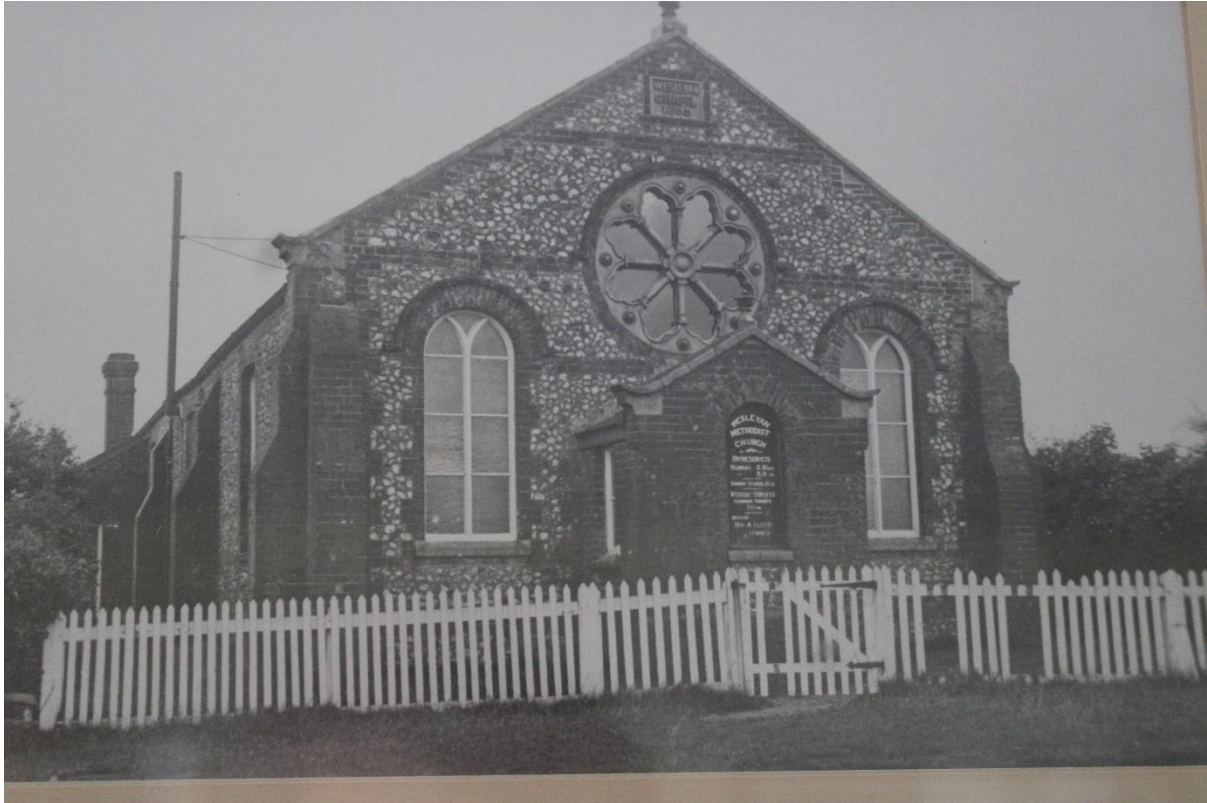
*Photograph from the 1930's prior to application of external render.*

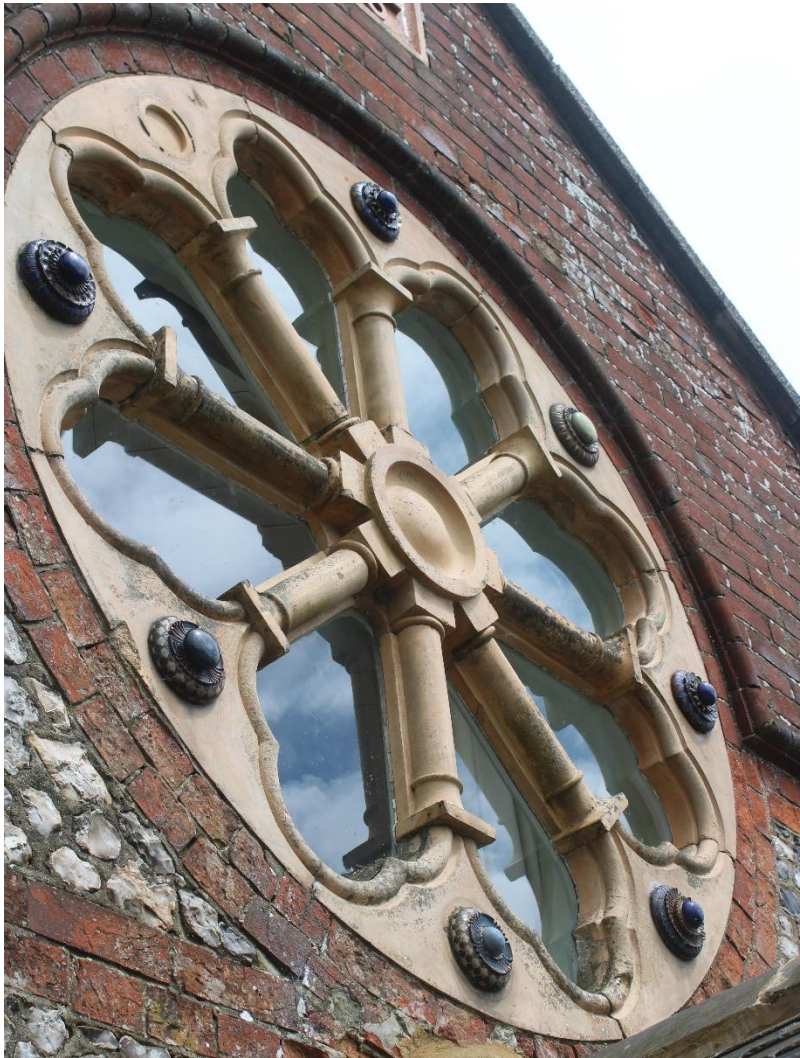
*Terracotta rose window to front elevation. Minor disrepair and some open joints but in reasonable condition. The gable above once in flint is now formed in brick.*

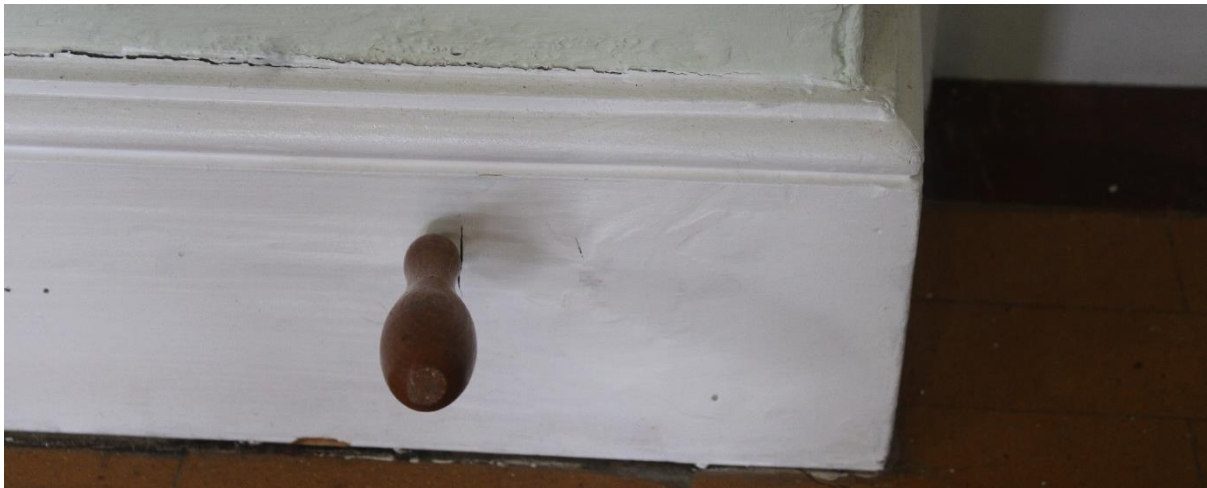
*Decayed section of skirting to wall between kitchen and main hall.*

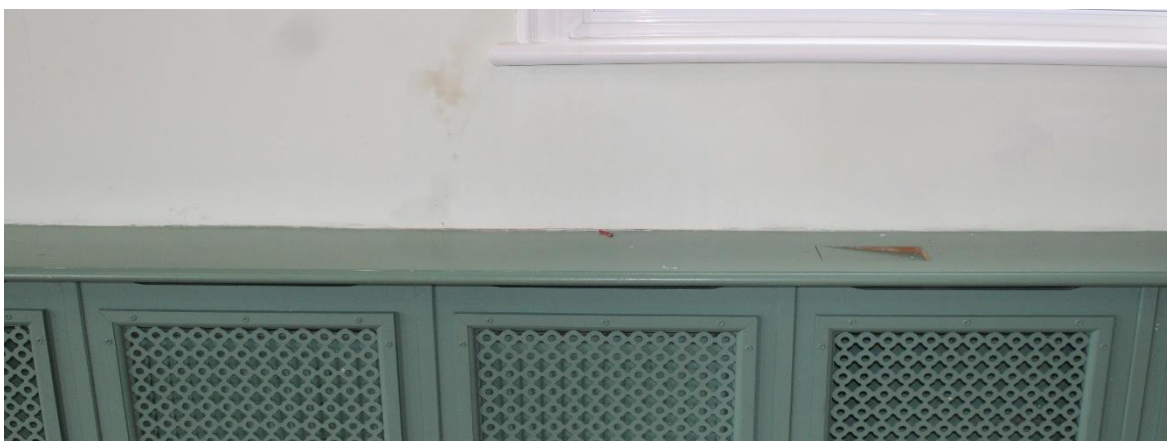
Rising ground moisture is normally prevented in modern buildings by using a damp proof course (DPC) at the base of the wall. The DPC is often made of slate, bitumen, or plastic. It is sometimes introduced retrospectively by the injection of chemicals which form a barrier. There is no visible evidence of a DPC at the base of the walls to this building and injecting a chemical DPC in a wall of this kind is unlikely to offer long term effective solution.

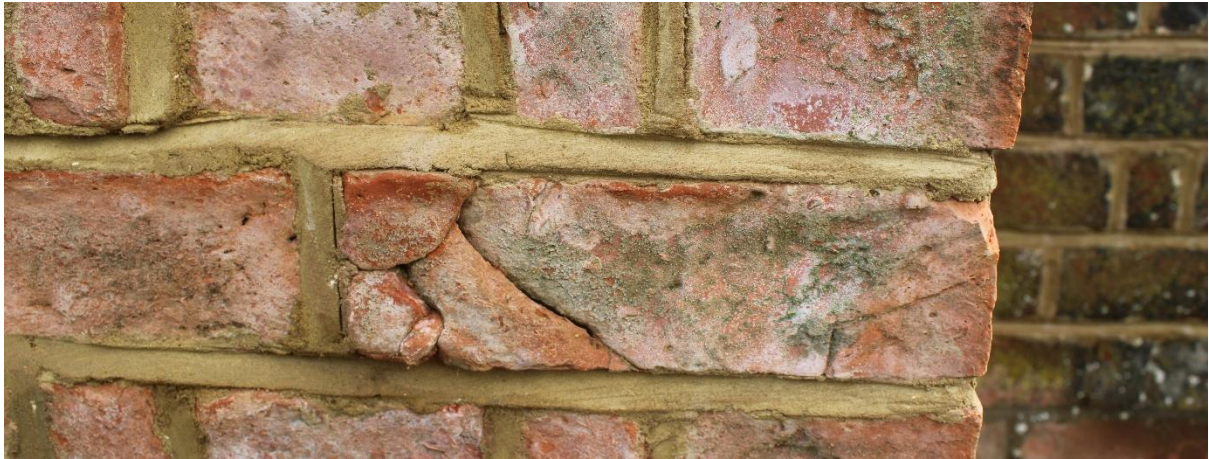
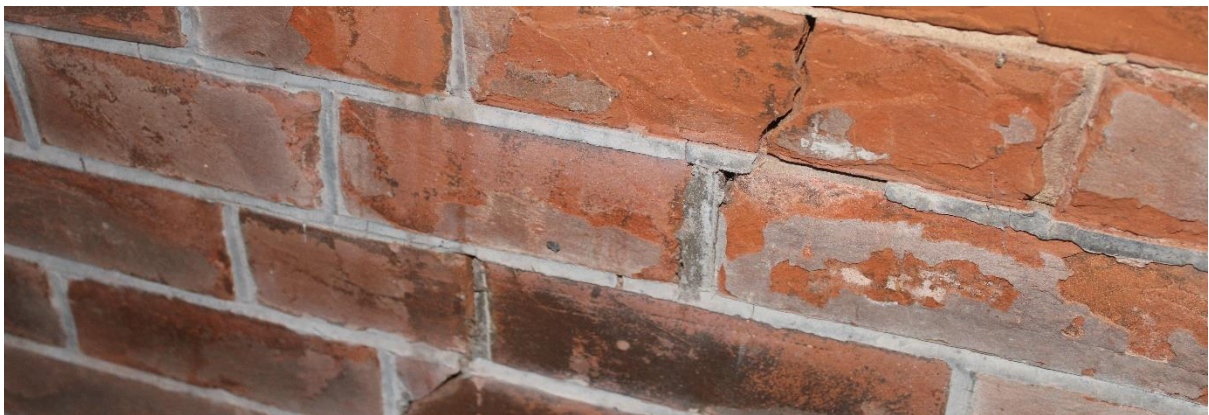
*Repointing is a highly skilled operation and should only be carried out by craftsmen/bricklayer/masons using historically appropriate materials.*

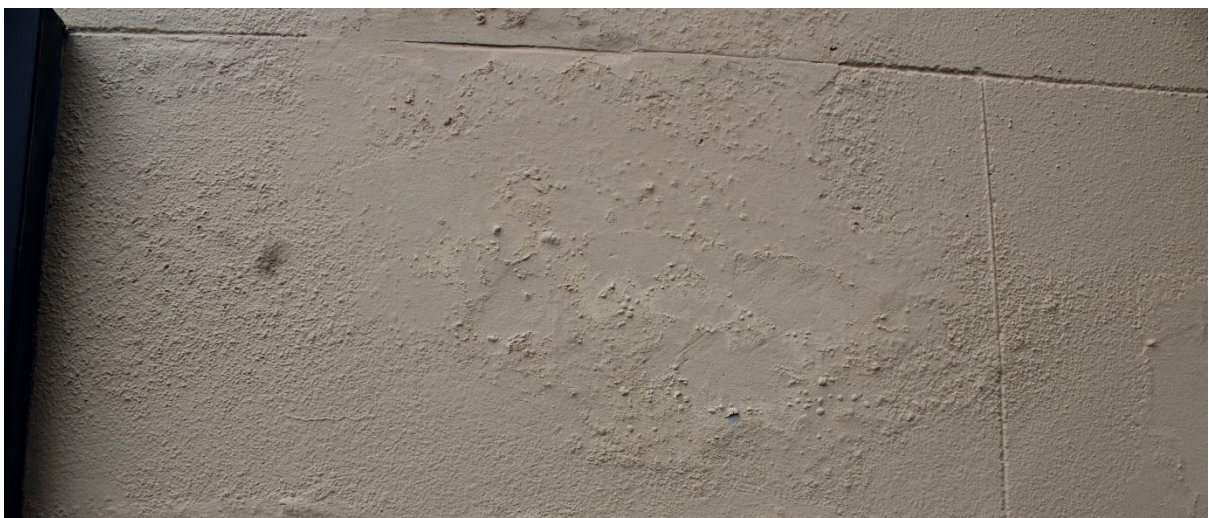
It is recommended that the remedial measures already outlined be undertaken initially. If the problem persists it may be necessary to dryline the walls internally. This has already been done in the small meeting room where there is no evidence of dampness on the walls. It is however important that the cavity between the lining and structural wall is ventilated and that the boarding and the framework to which it is fixed is moisture resistant.

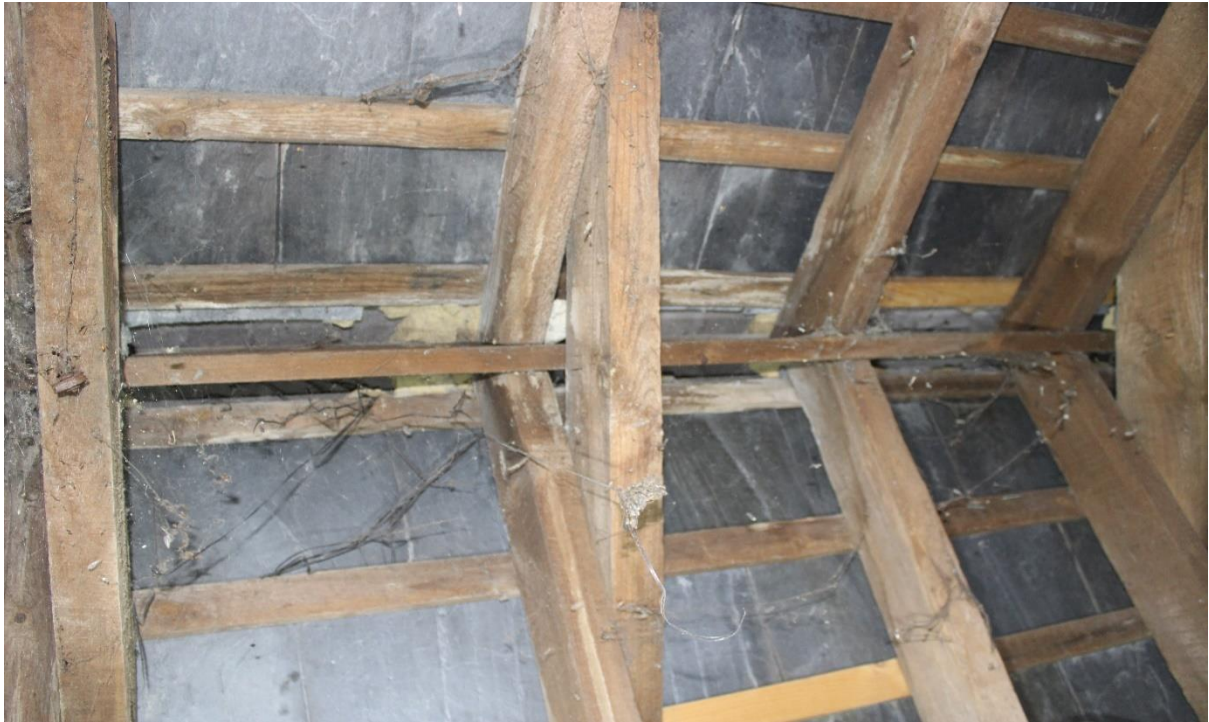
*Underside of roof: note no underlay and damp staining to timbers.*

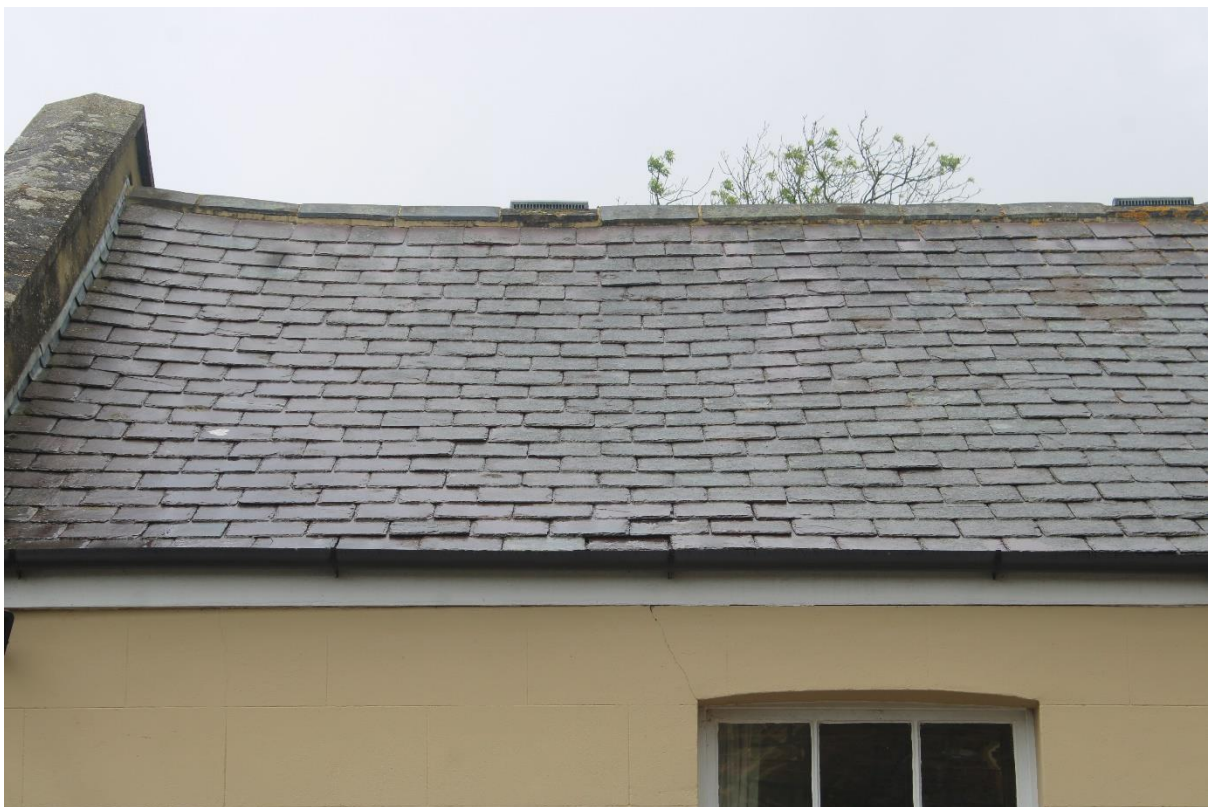
*Roof surface: note parapet upstand, slight sagging, vent tiles set along ridge and fascia board fixed tight to wall.*

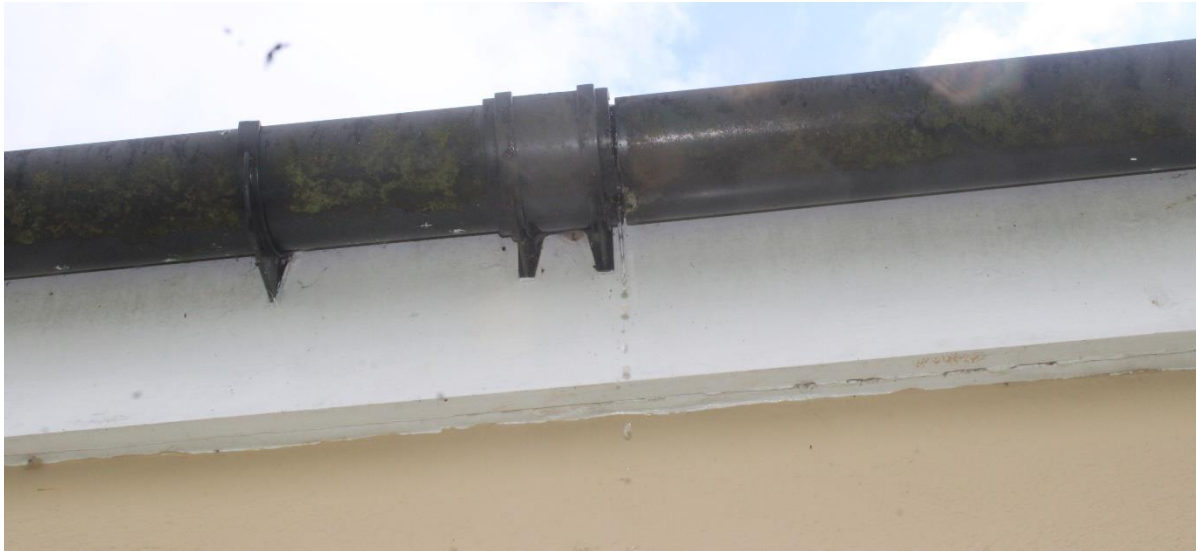
*Leaking plastic gutter.*

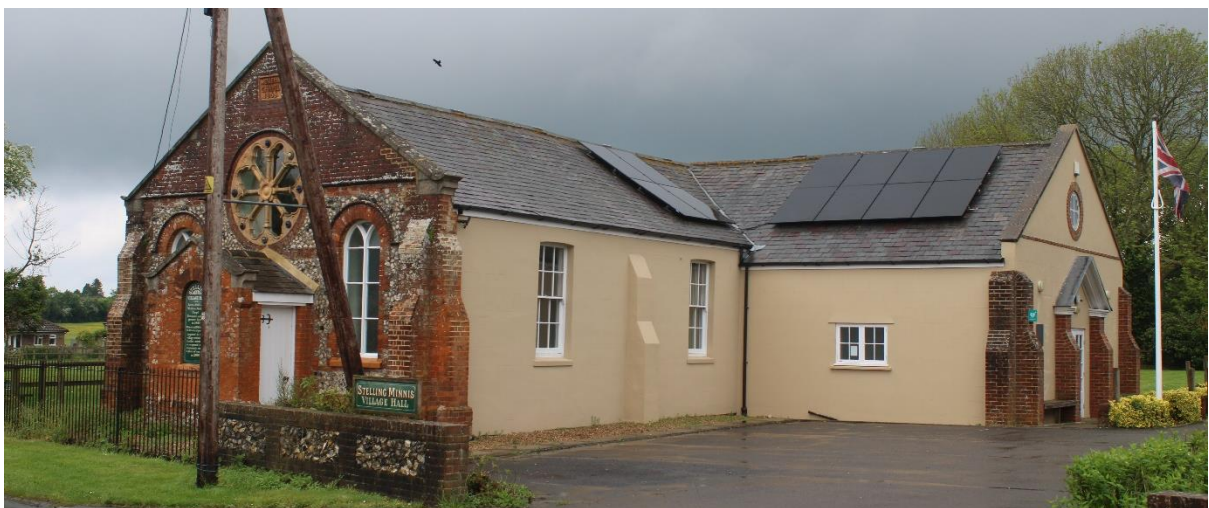
The failure of rainwater goods is the primary cause of damage to buildings.

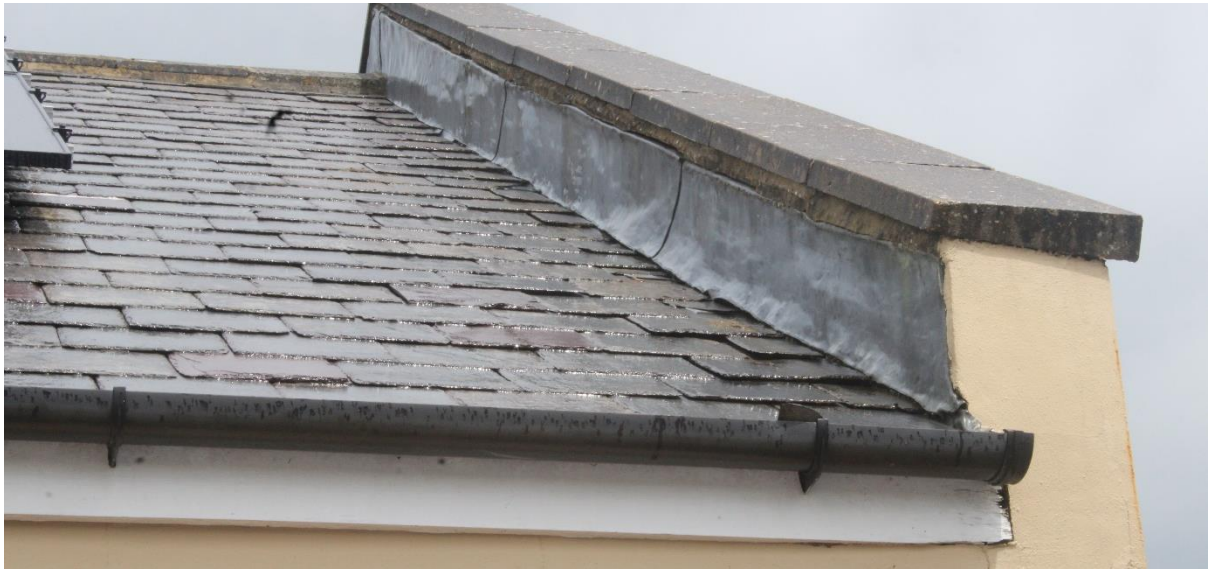
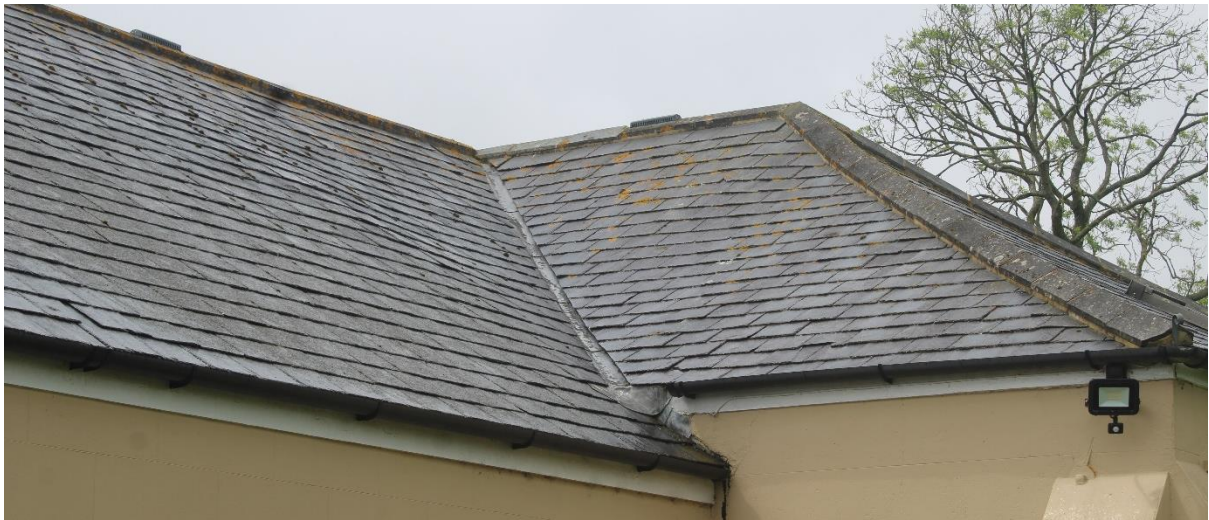
*Lead detailing to valleys and parapets need regular maintenance.*

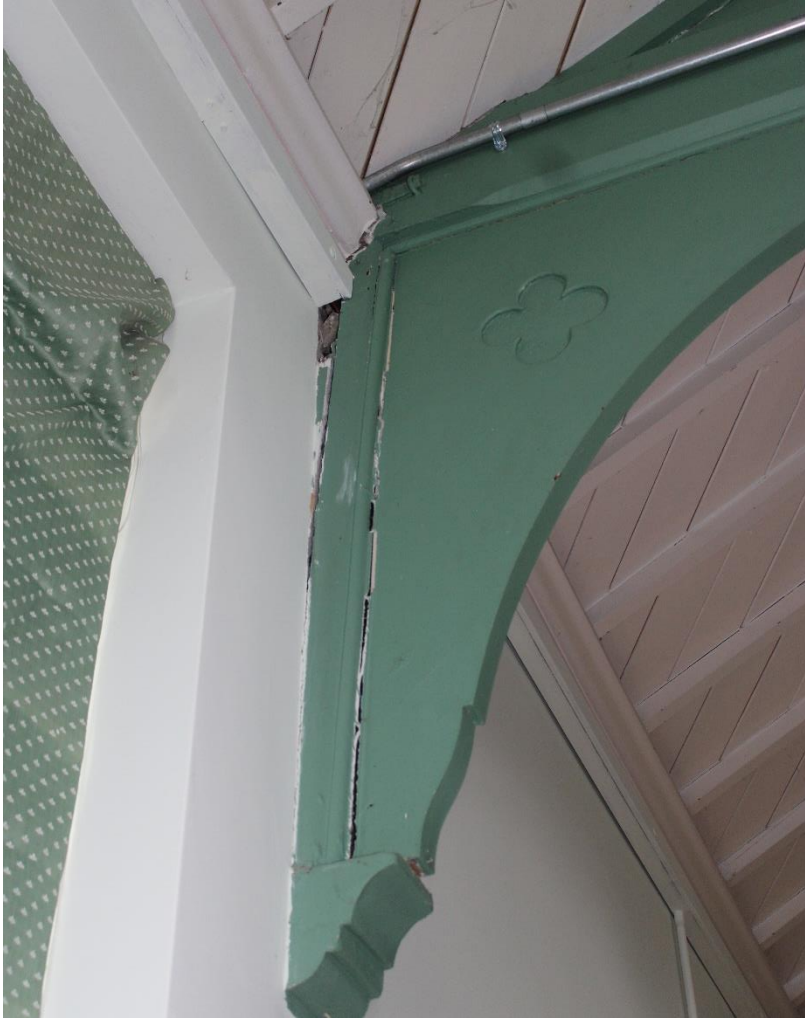
*Open joint to side of post and wall and spandrel panel to one of the trusses in the main hall.*

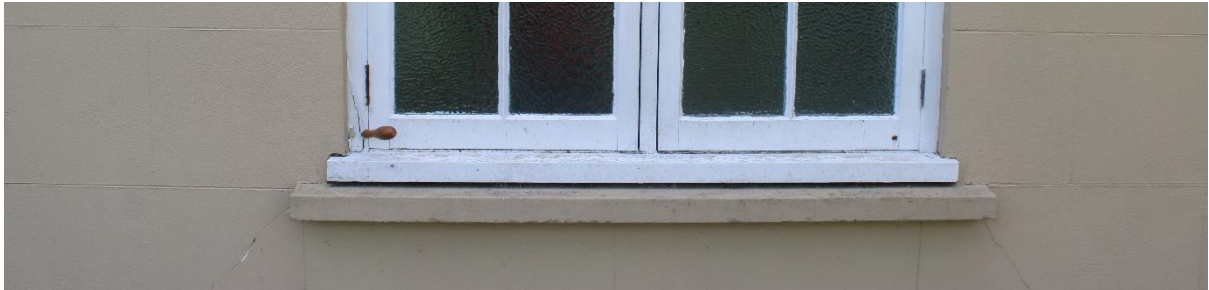
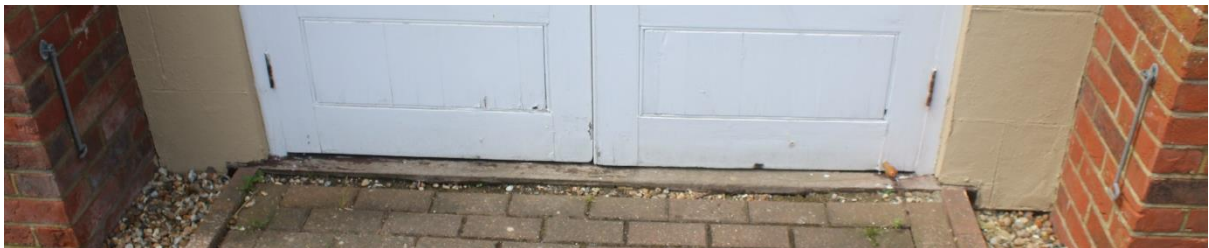
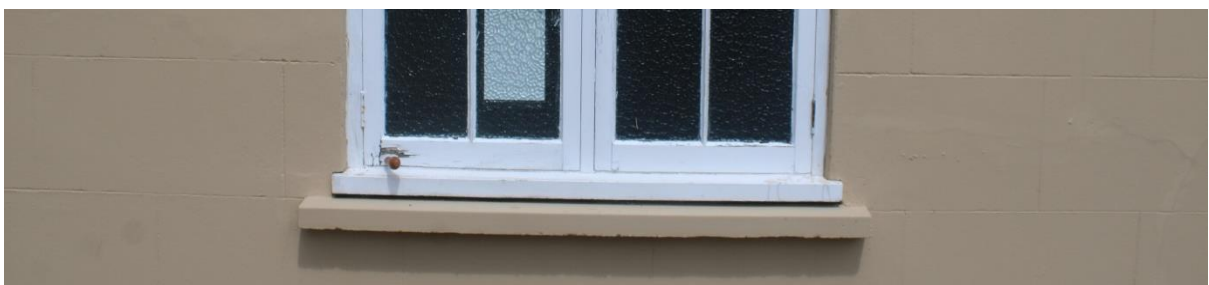
The timber architrave to the canopy over the main entrance is decayed and localised repairs are needed to fascia boards. In both locations the lead detailing should be checked and refixed or redressed as needed.

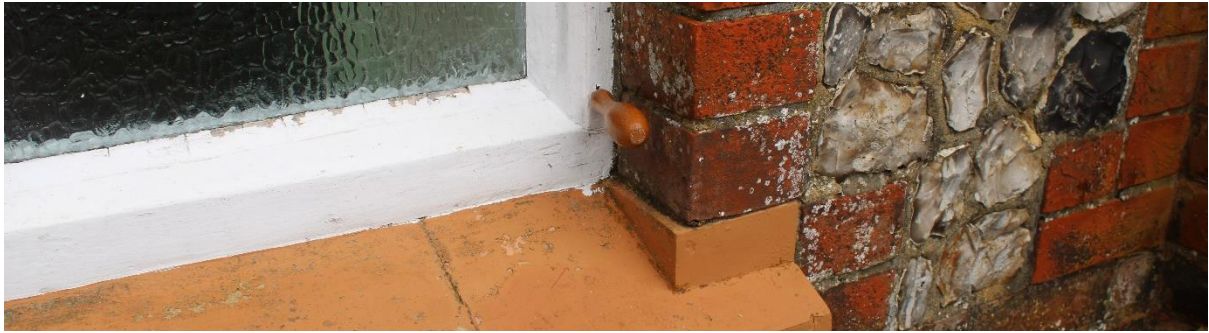
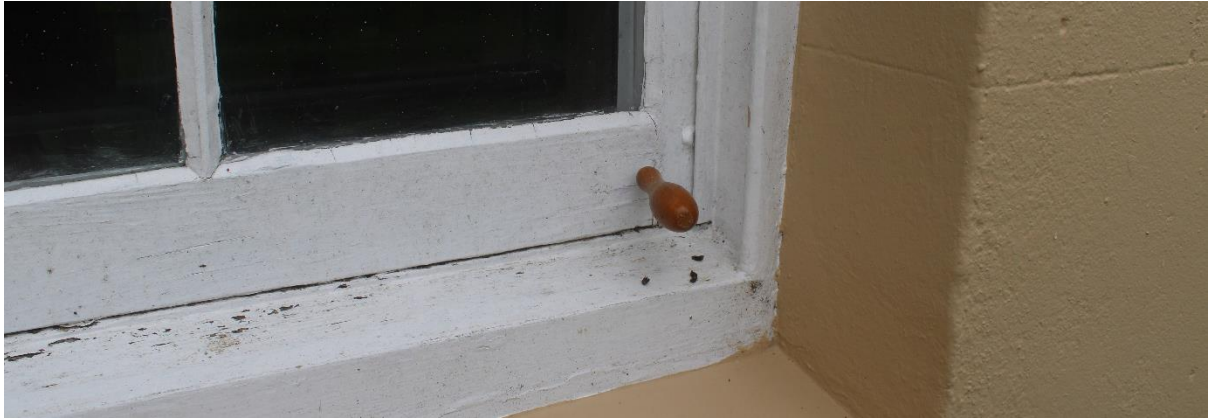
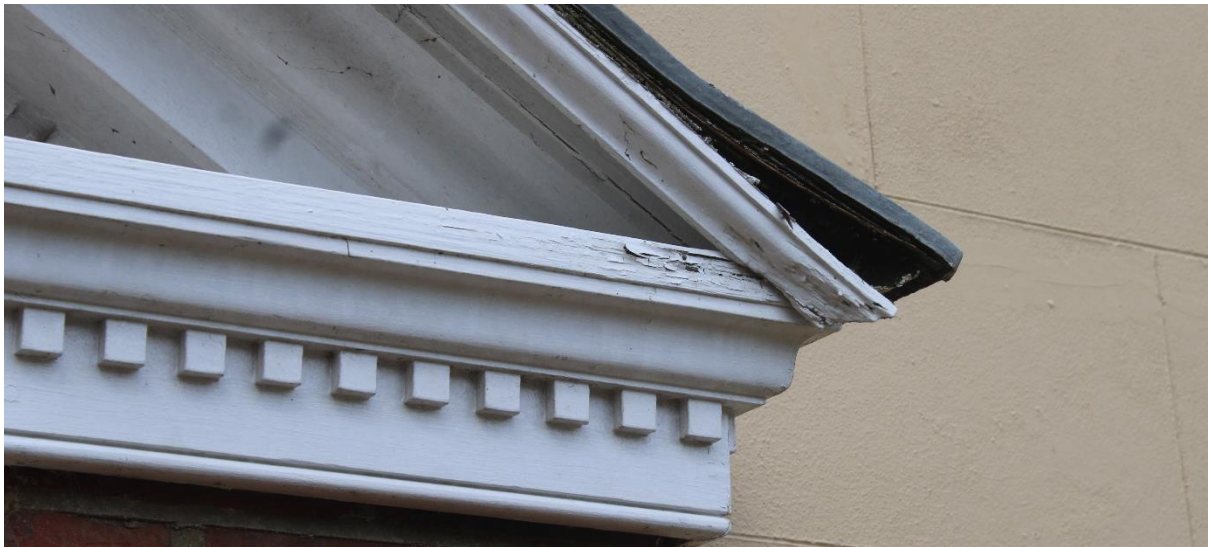
*Localised decay to doors, windows and other external joinery can be attended to as part of routine maintenance. It is not excessive.*

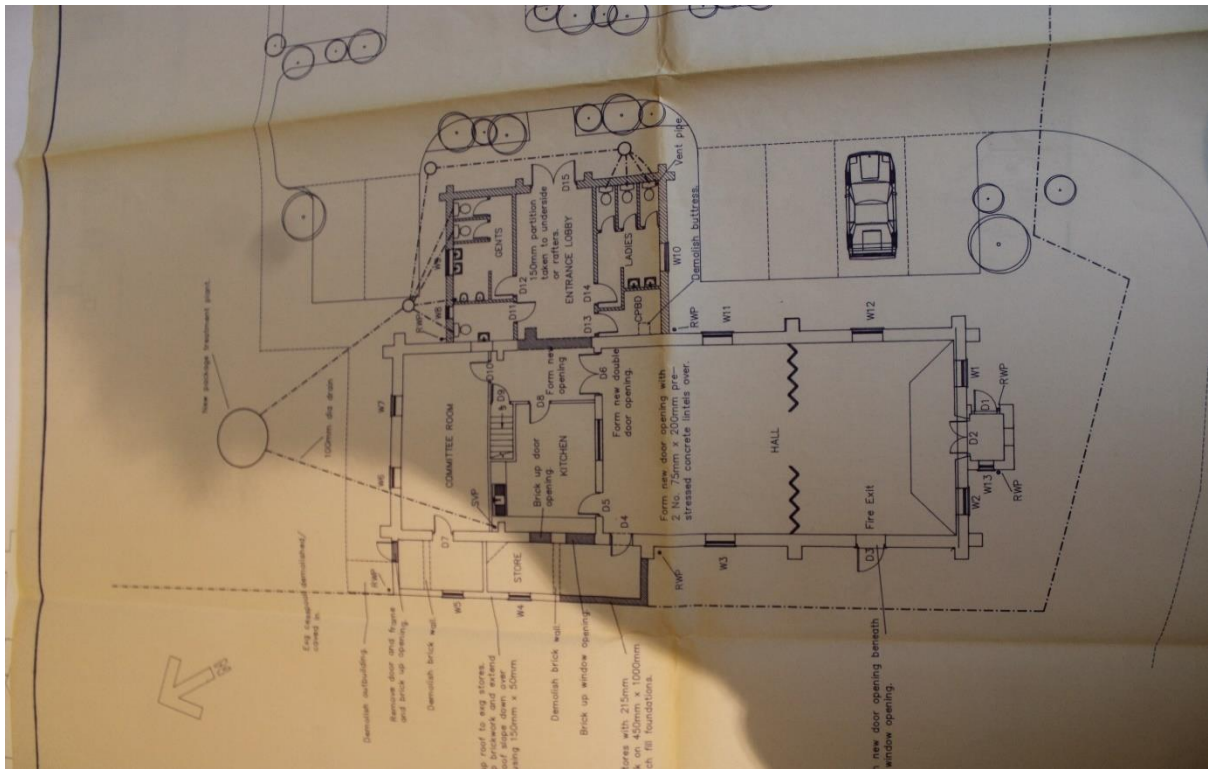
2001 extension drawing
